Reliability Laboratory

TEST REPORT

Report No.: HC20093A/2008

1. Industrial Communication Computer
2. JetNet PoE Switch
3. Industrial Fast Ethernet to Fiber Media Converter

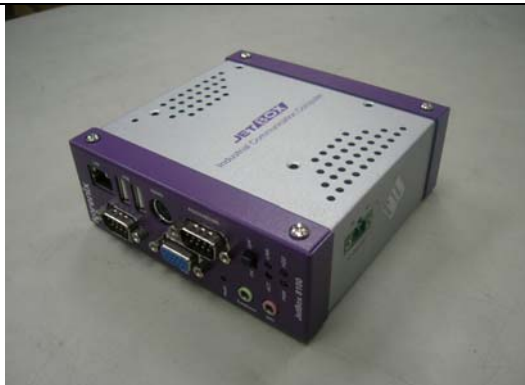
<p>1. Appearance of specimen (JetBox8100)</p>	<p>2. Appearance of specimen (JetBox9310)</p>

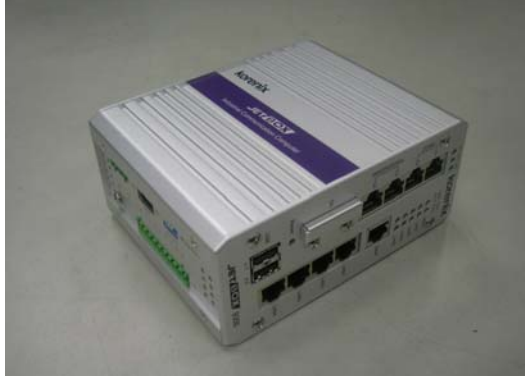
<p>3. Appearance of specimen (JetBox9300)</p>	<p>4. Appearance of specimen (JetBox8210)</p>

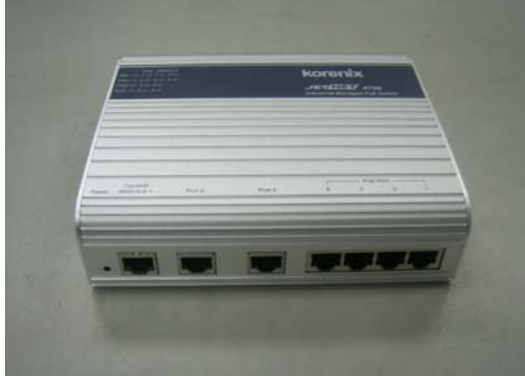
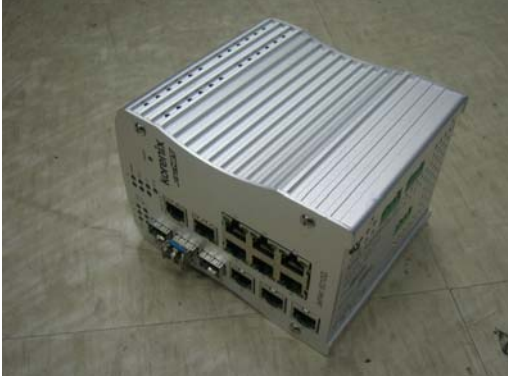
<p>5. Appearance of specimen (JetNet 4706)</p>	<p>6. Appearance of specimen (JetNet 5010G)</p>

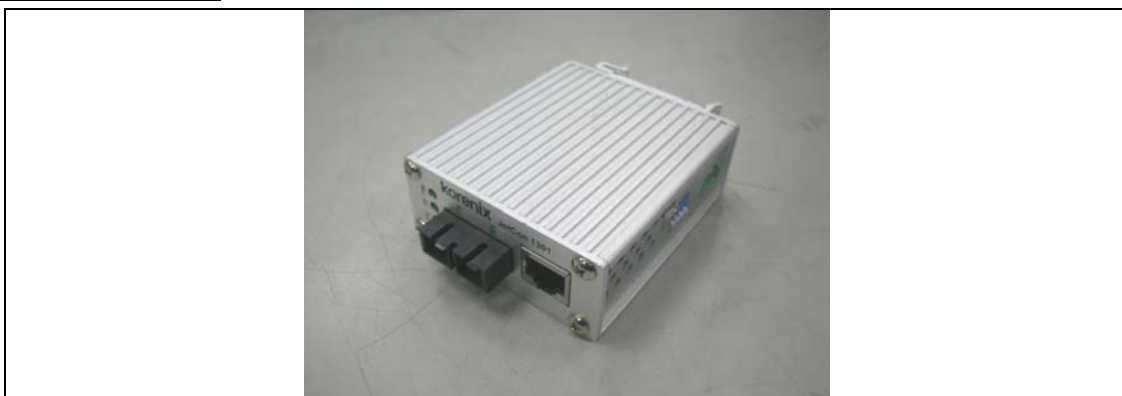
7. Appearance of specimen
(JetCon 1301-s)

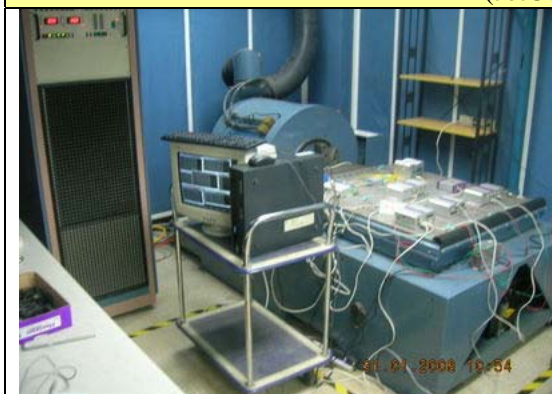
8. Vibration test--X axis

Direction: X, Y, Z axes (see photo 8~13)

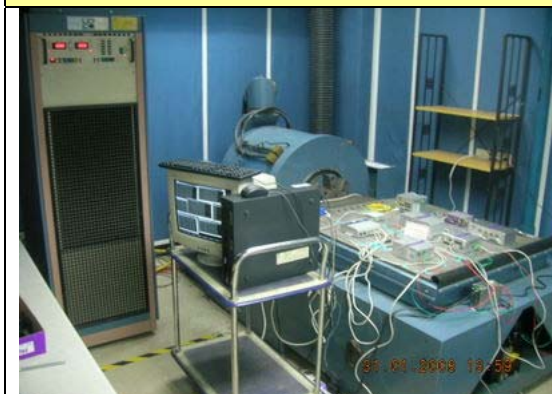
10. Vibration test--Y axis
